***INSPECTION AND INTERIOR CLEANING (SEDIMENT REMOVAL)
OF THE GREAT HILL 750,000-GALLON WELDED STEEL
WATER STORAGE TANK***

***TOWN OF NEWMARKET WATER DEPARTMENT
NEWMARKET, NEW HAMPSHIRE***

MAY 23, 2018

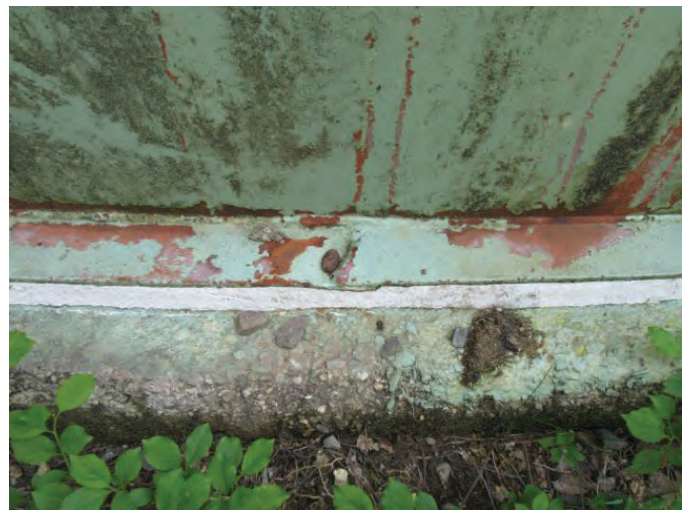
Secondary coating adhesion loss was also observed throughout approximately 10% of the lower 10' of the exterior walls, resulting in exposure of the primary coating.

A mild to moderate, non-uniform accumulation of mildew throughout the exterior walls causes declined aesthetics.

10 *Exterior Wall With Secondary Coating Loss, Exposed Primary Coating And Mild To Moderate Mildew*

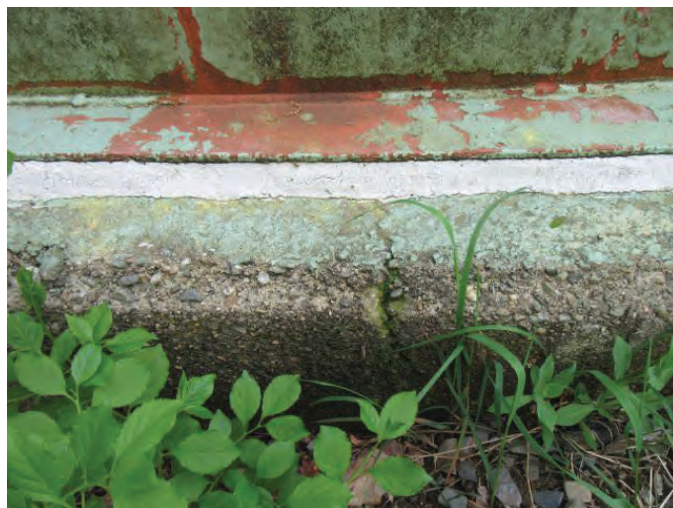
11 *Exterior Wall With Secondary Coating Loss, Exposed Primary Coating And Mild To Moderate Mildew*

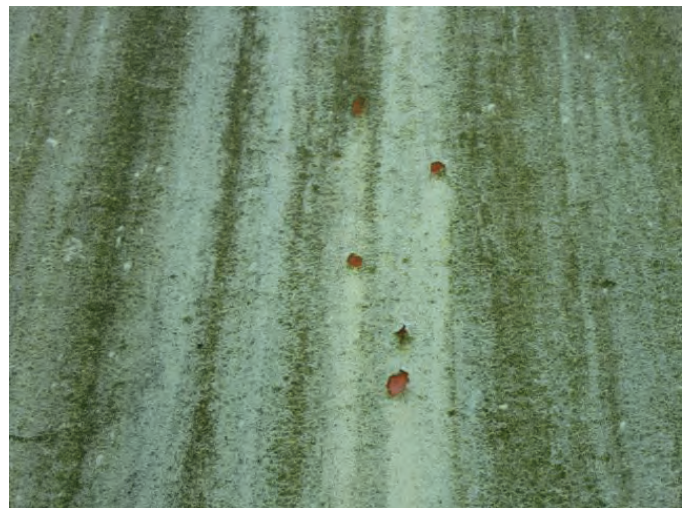
12 *Exterior Wall With Secondary Coating Loss, Exposed Primary Coating And Mild To Moderate Mildew*

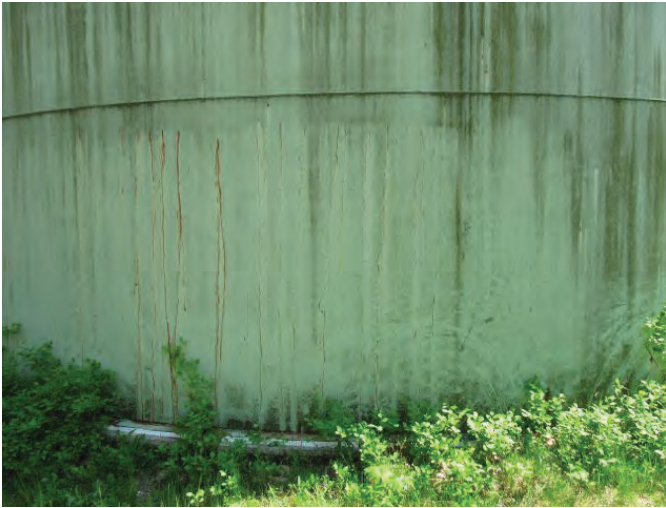
13 *Exterior Wall With Secondary Coating Loss, Exposed Primary Coating And Mild To Moderate Mildew*

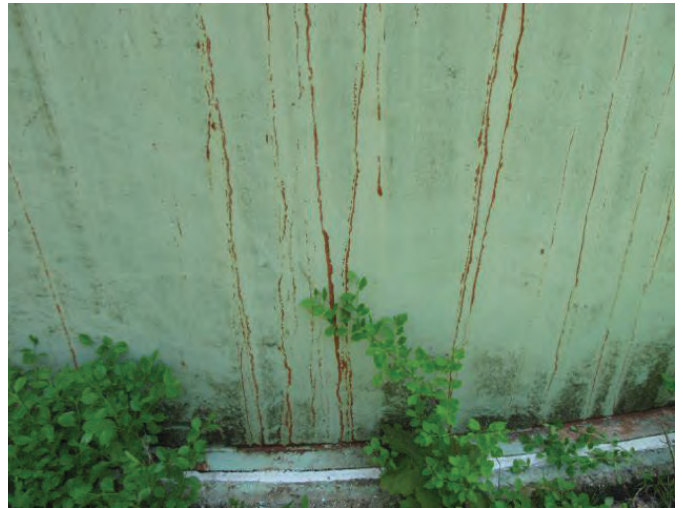
14 *Exterior Wall With Secondary Coating Loss, Exposed Primary Coating And Mild To Moderate Mildew*

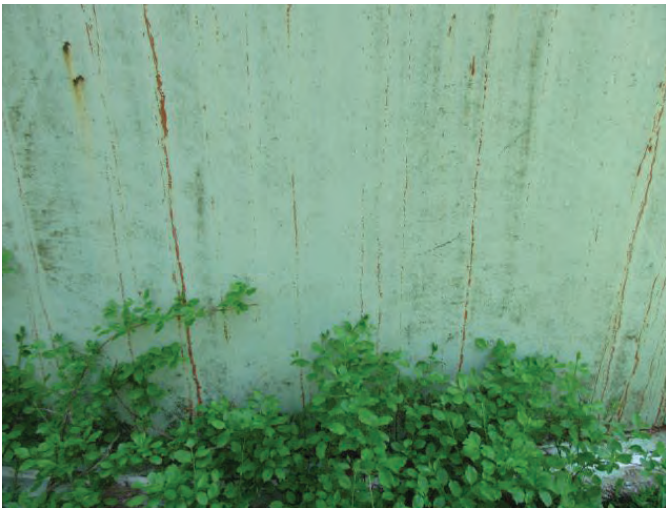
15 *Exterior Wall With Secondary Coating Loss, Exposed Primary Coating And Mild To Moderate Mildew*

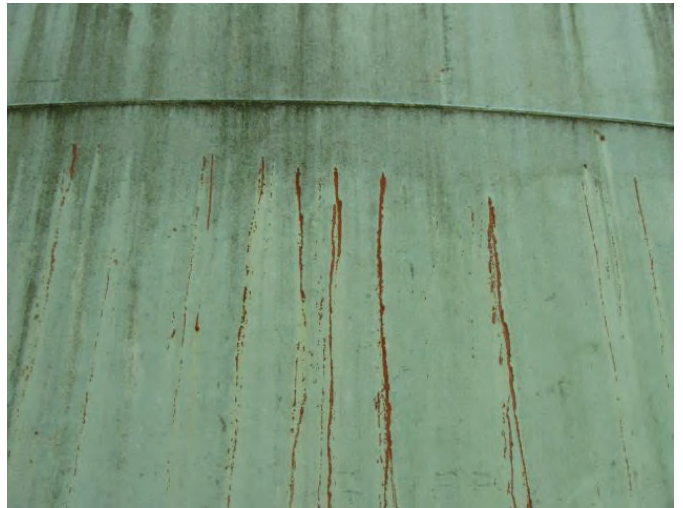
16 *Exterior Wall With Secondary Coating Loss, Exposed Primary Coating And Mild To Moderate Mildew*

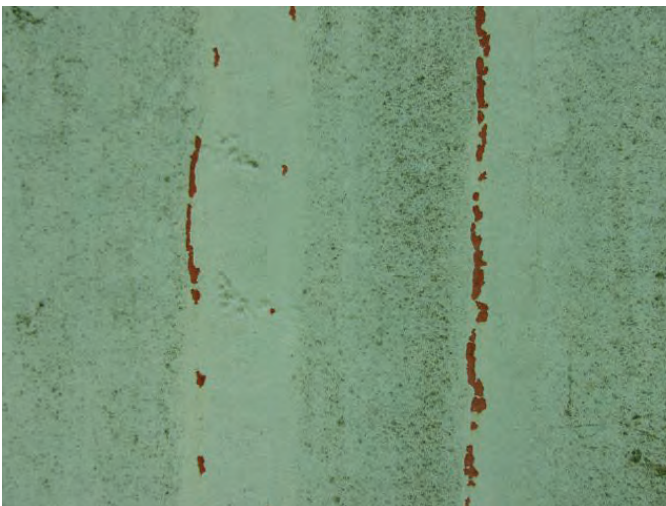
17 *Exterior Wall With Secondary Coating Loss, Exposed Primary Coating And Mild To Moderate Mildew*

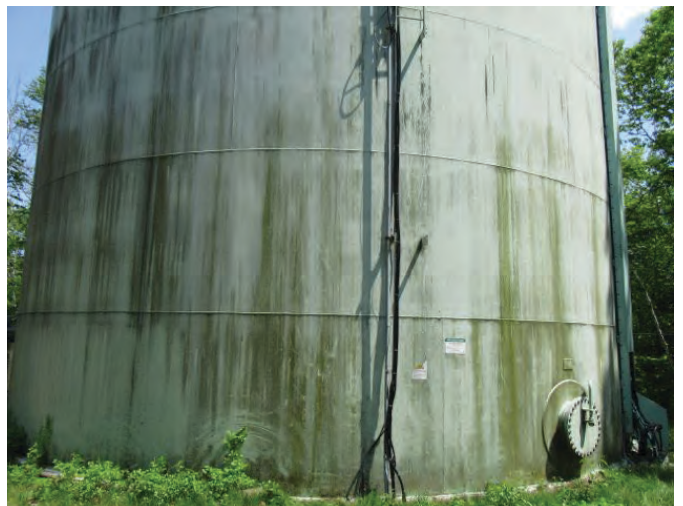
18 *Exterior Wall With Mild To Moderate Mildew*

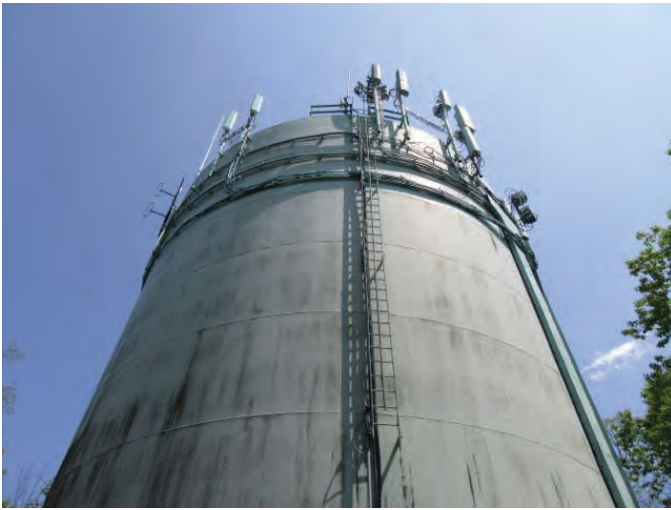
19 *Exterior Wall With Mild To Moderate Mildew*

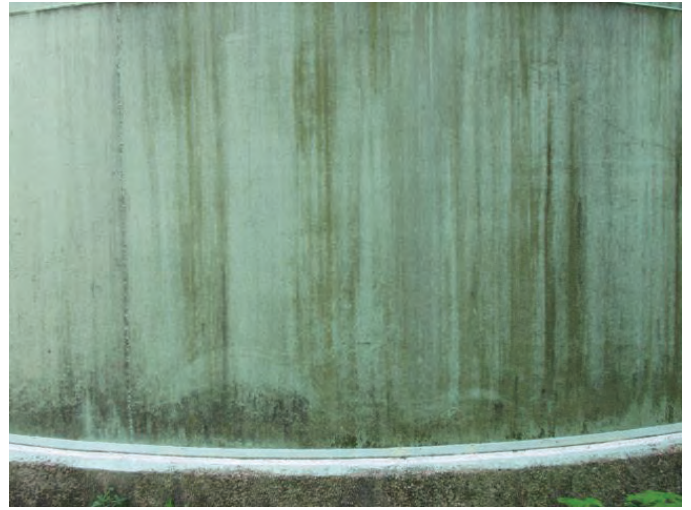
20 *Exterior Wall With Mild To Moderate Mildew*

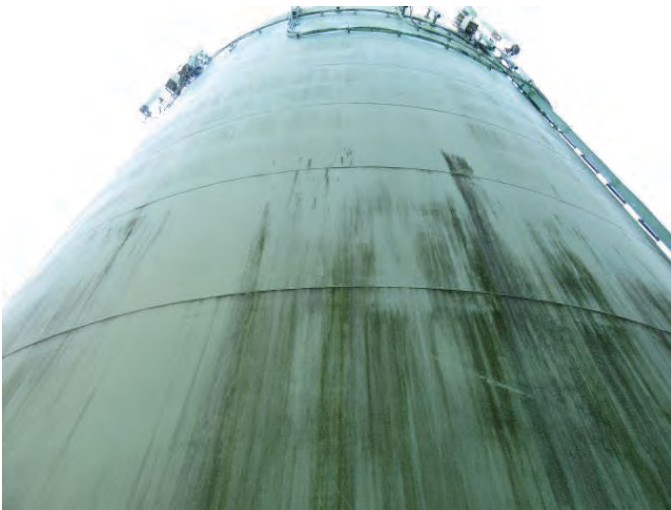
21 *Exterior Wall With Mild To Moderate Mildew*

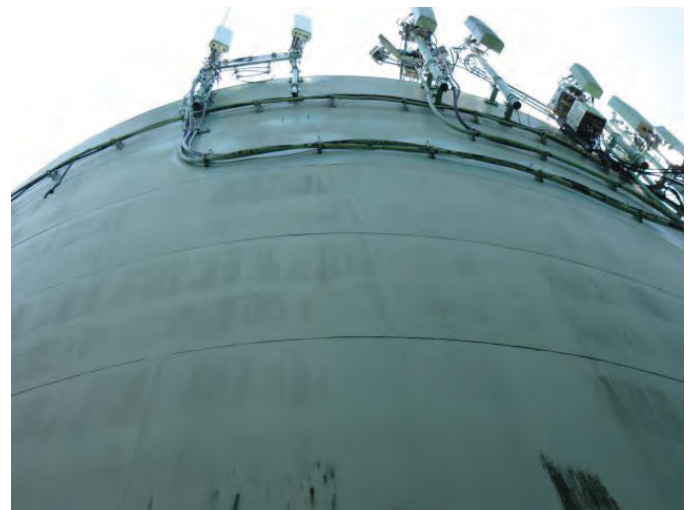
22 *Exterior Wall With Mild To Moderate Mildew*

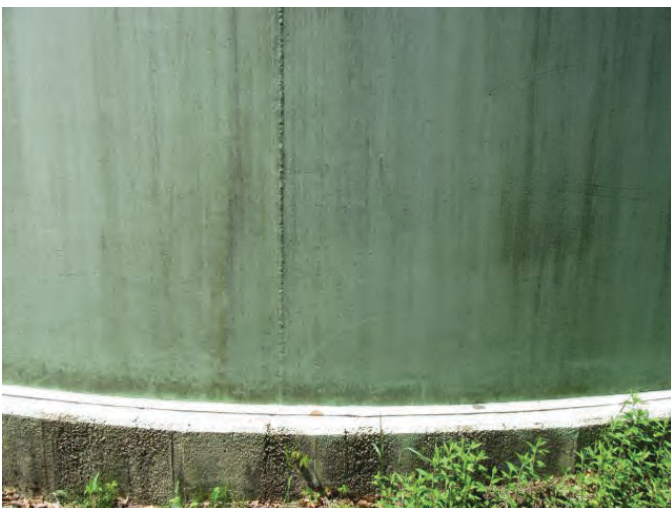
23 *Exterior Wall With Mild To Moderate Mildew*

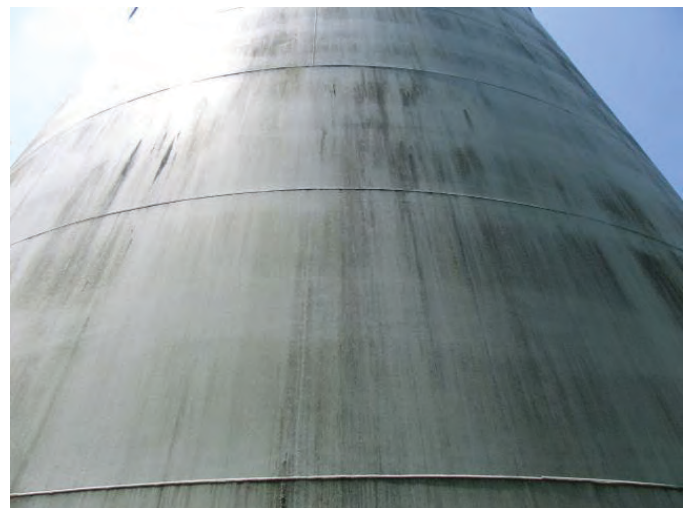
24 *Exterior Wall With Mild To Moderate Mildew*

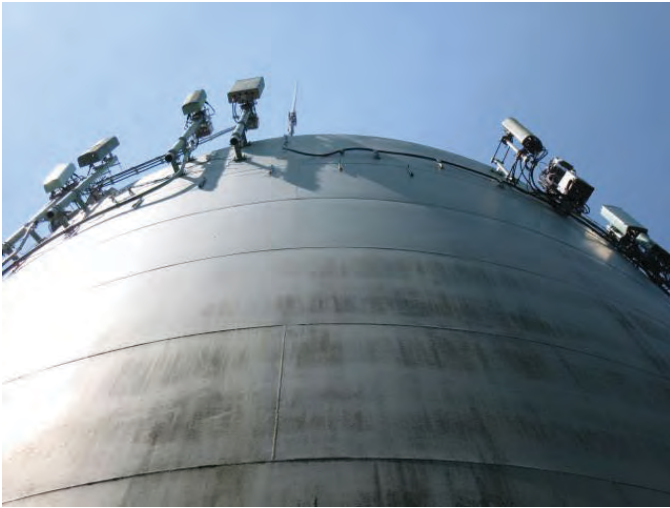
25 *Exterior Wall With Mild To Moderate Mildew*

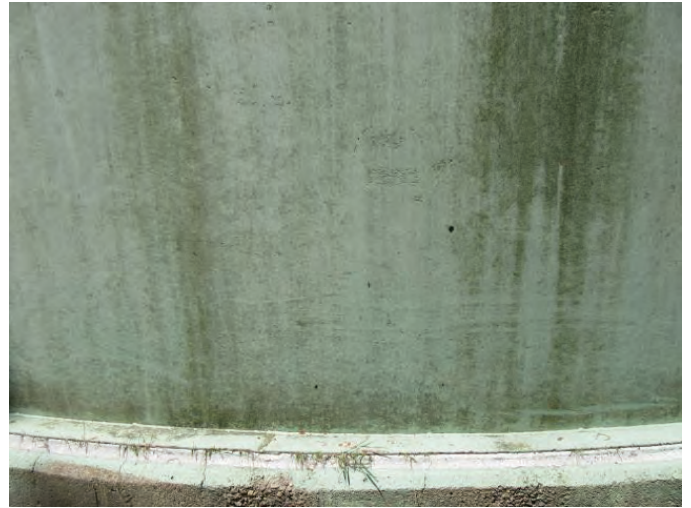
26 *Exterior Wall With Mild To Moderate Mildew*

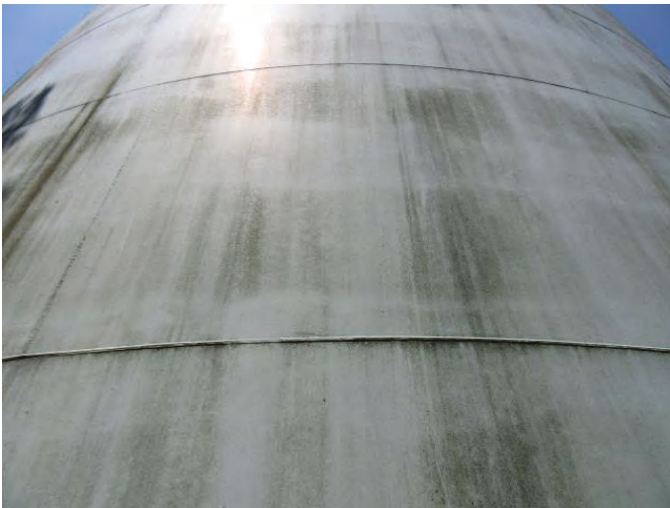
27 *Exterior Wall With Mild To Moderate Mildew*

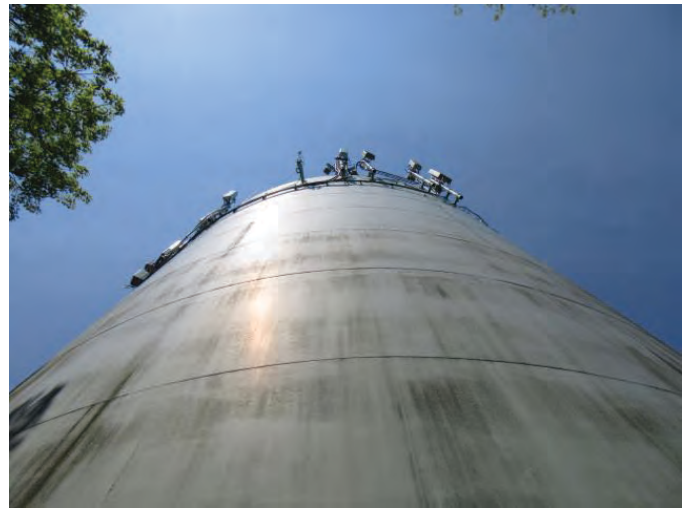
28 *Exterior Wall With Mild To Moderate Mildew*

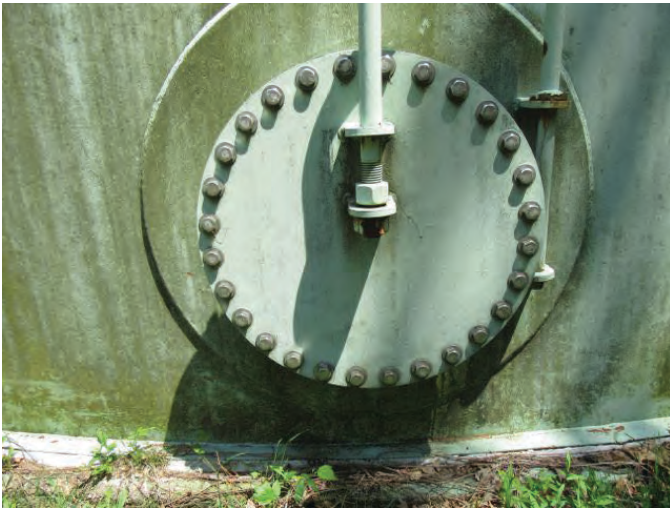
Two, 24" inside diameter manways penetrate the lowest row of wall panels on the easternmost and westernmost sides of the tank, located approximately 18" above the tank base and are securely installed and free of obvious leakage.

33 *Secure Manway*

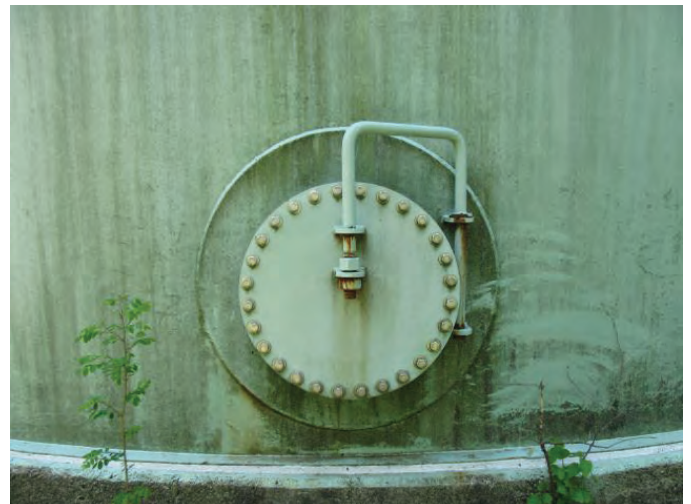
36 *Secure Manway*

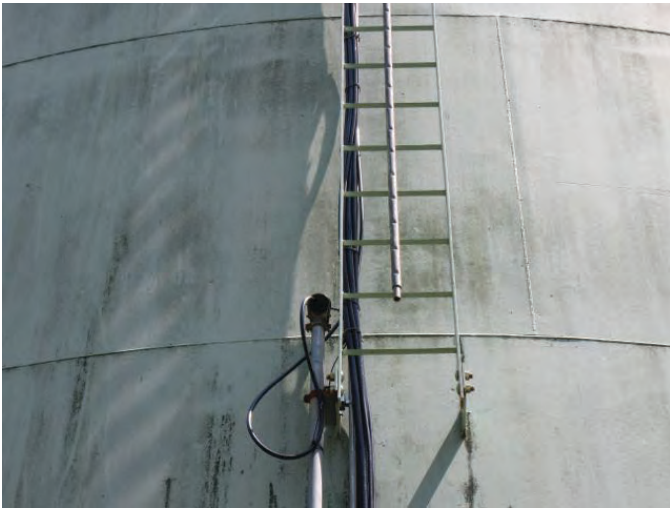
This ladder and fall prevention device remains in good sound condition, providing safe access to the roof.

39 *Ladder With A Fall Prevention Device*

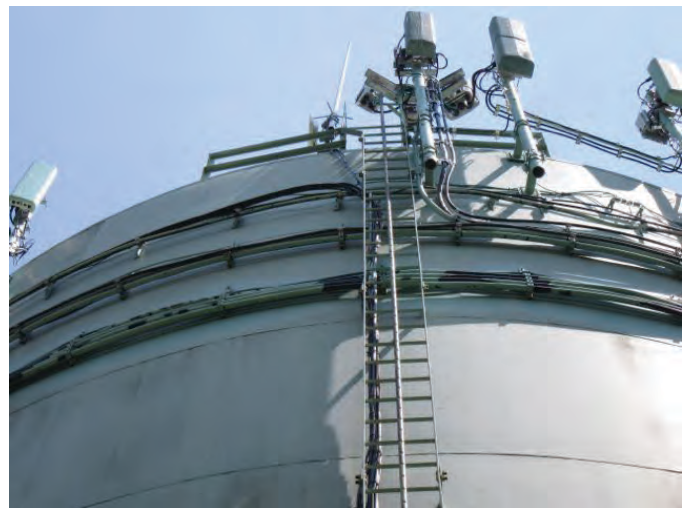
40 *Ladder With A Fall Prevention Device*

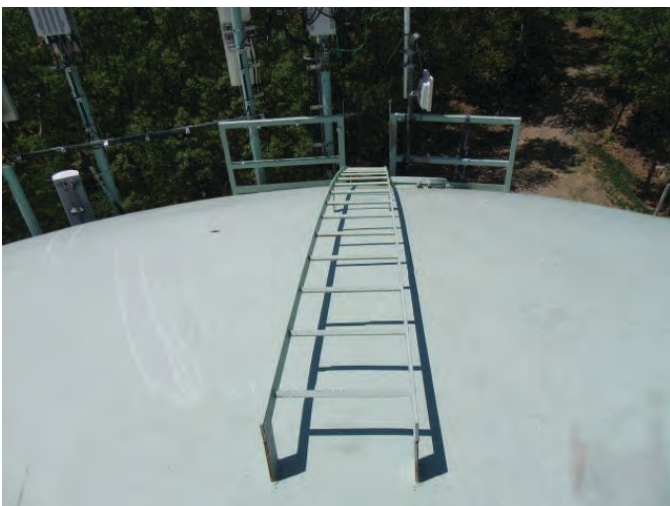
A second welded steel ladder extends from the edge of the roof dome up to the vent, supported to the roof with three sets of welded standoffs. This ladder remains in good sound condition, providing good access to the vent.

The protective coating applied to this steel ladder appears to have been applied uniformly, although a decline in the coating film thickness causes minimal steel exposure and corrosion. However, this ladder remains sound and free of obvious fatigue/deterioration.

41 *Vent Access Ladder*

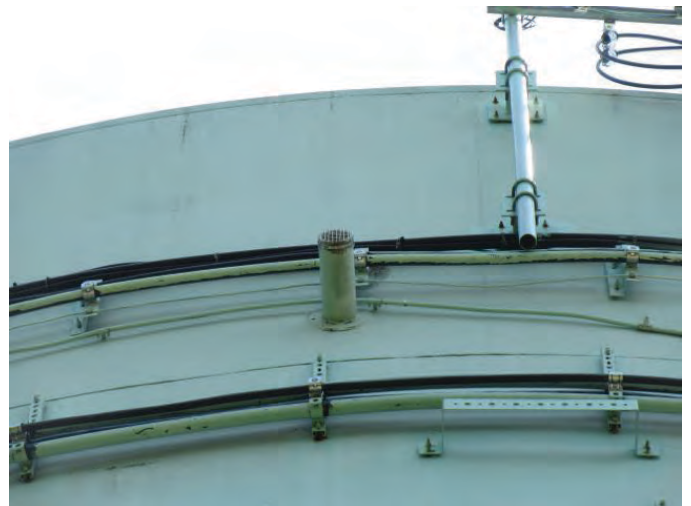
This overflow pipe was free of obvious obstructions and was found with a screen installed over its end, preventing access to the interior of the tank.

42 *Secure Overflow Pipe Screen*

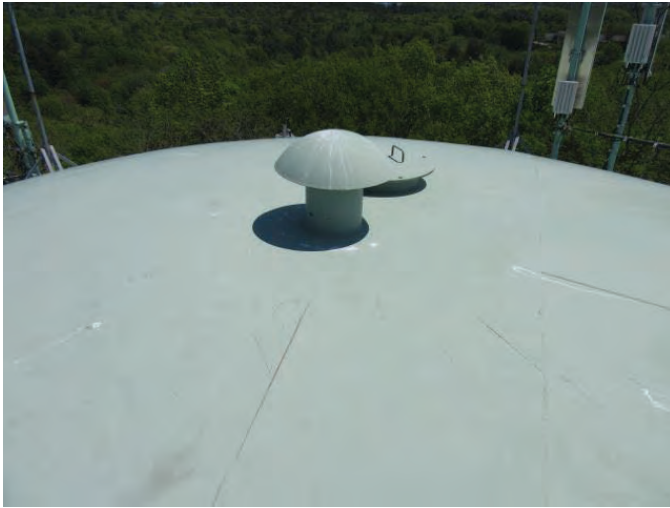
The protective coating applied to the roof has an average dry film thickness of 20.0 mils and appears to have been applied uniformly, meets the AWWA's recommendations and was found having good adhesion value; however, the protective coating has become chalky due to weathering.

43 *Steel Roof Panels With Coating Loss/ Chalking Due To Weathering*

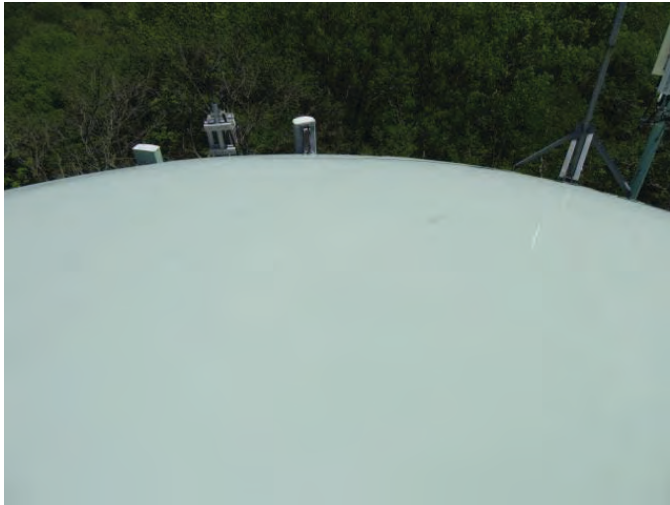
45 *Steel Roof Panels With Coating Loss/ Chalking Due To Weathering*

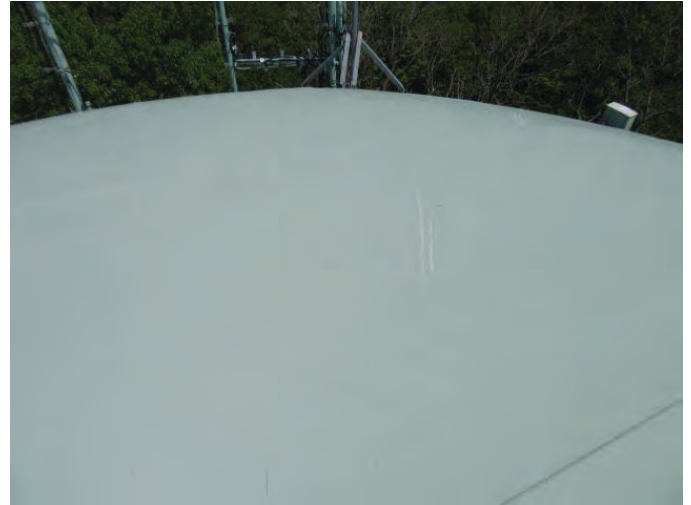
46 *Steel Roof Panels With Coating Loss/ Chalking Due To Weathering*

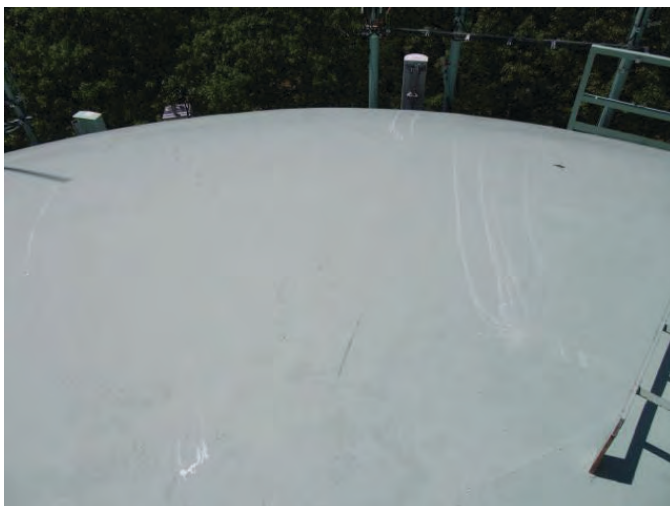
47 *Steel Roof Panels With Coating Loss/ Chalking Due To Weathering*

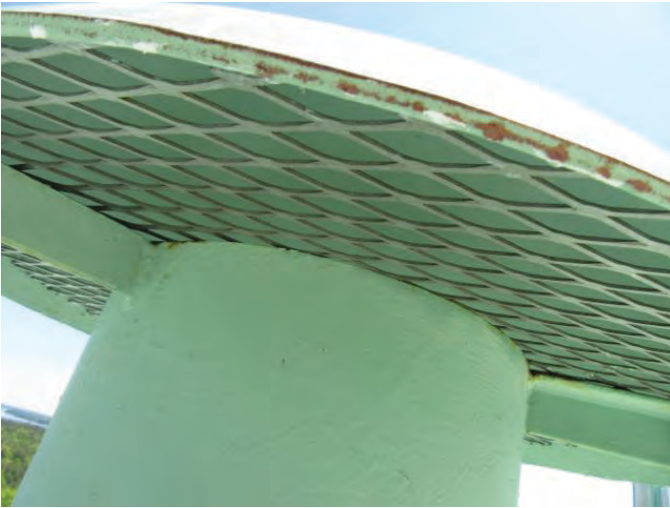
51 *Secure Vent Screen*

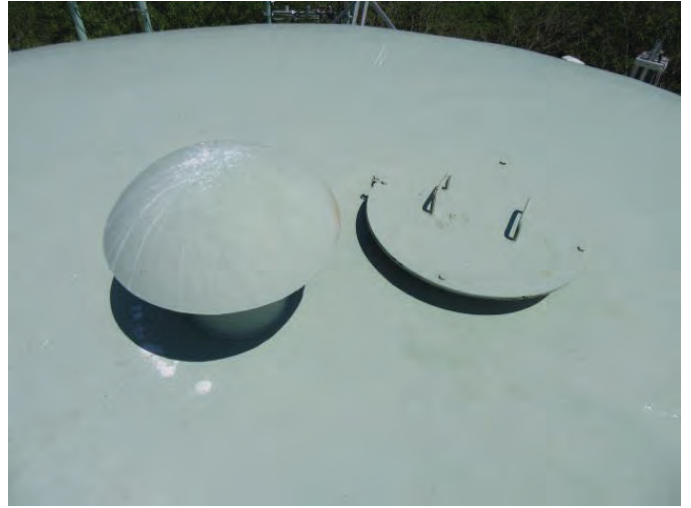
The 23-1/2" inside diameter hatch remains in good working condition and was found secured with a lock, preventing unwanted access to the interior of the tank.

52 *Secure Access Hatch*

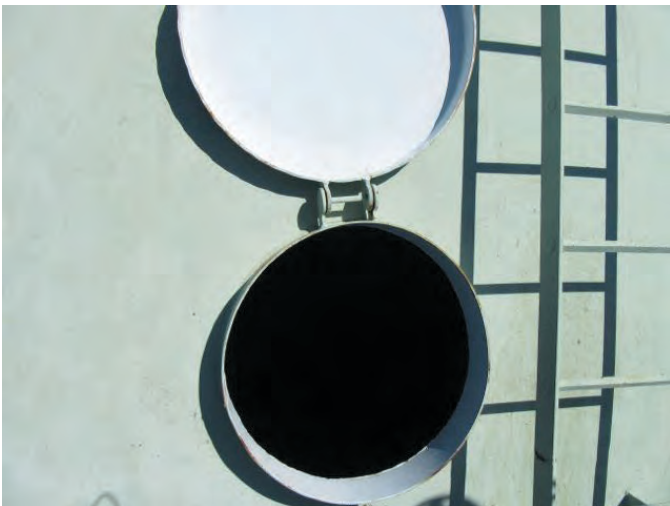
53 *Open Access Hatch*

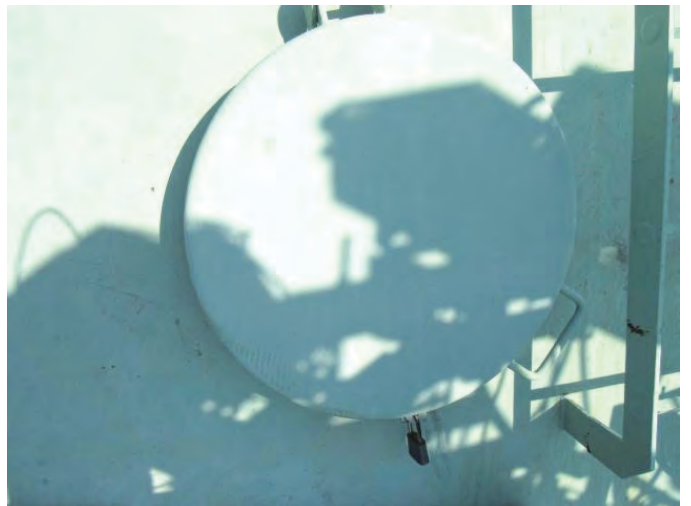
54 *Closed Access Hatch*

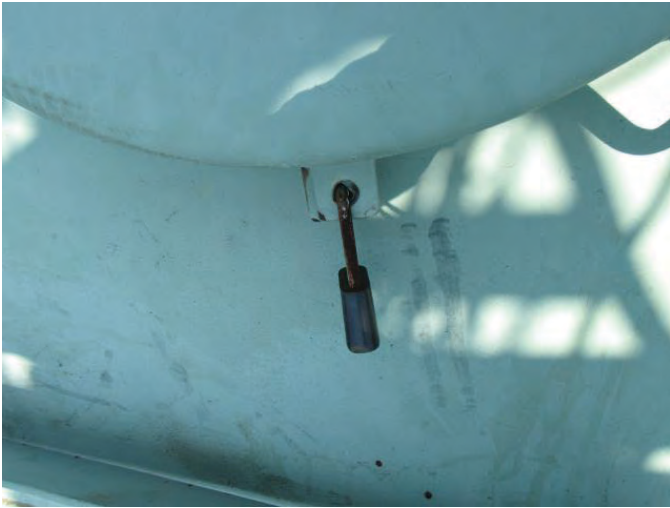
The protective coating applied to each steel hatch was found having good adhesion value at this time.

55 *Secure Access Hatch*

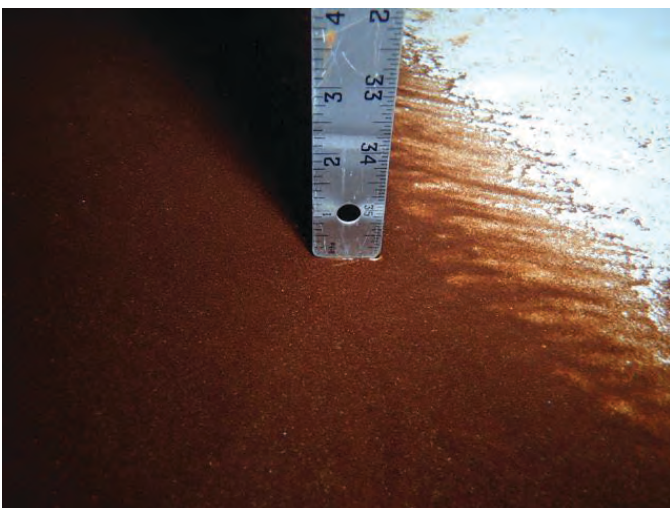
59 *Layer Of Precipitate*

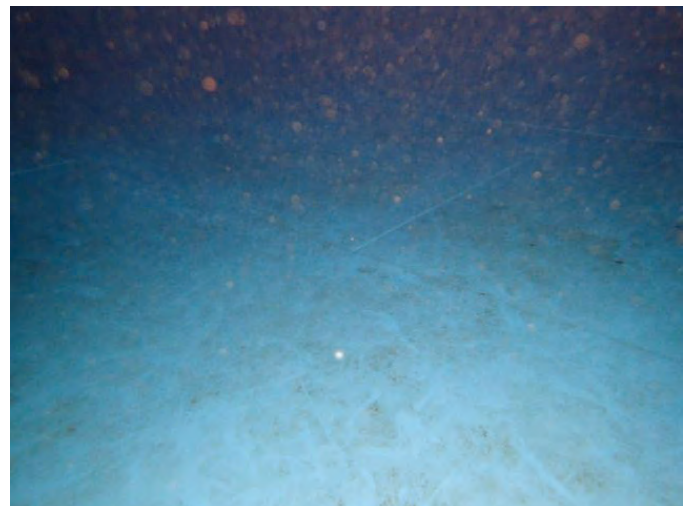
66 *Floor With Mild Staining*

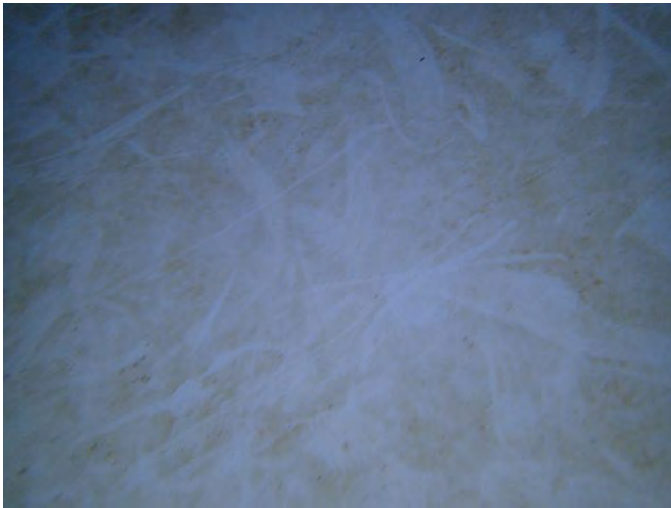
67 *Floor With Mild Staining*

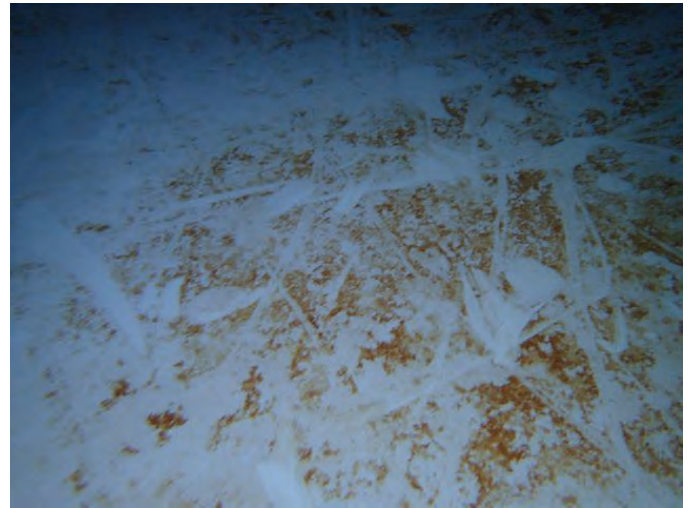
68 *Floor With Mild Staining*

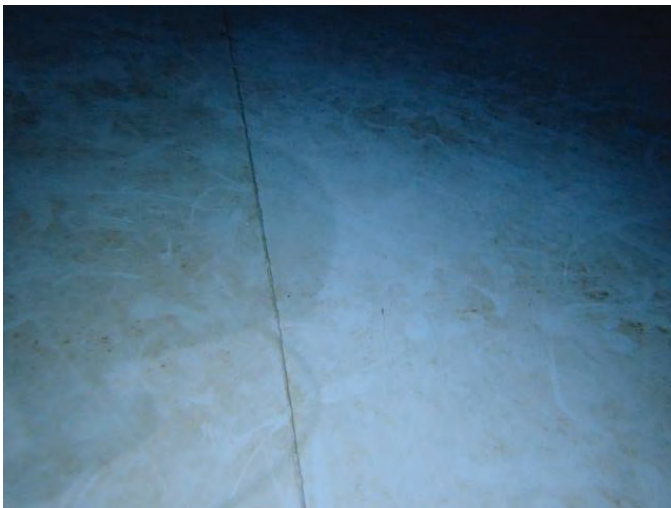
69 *Floor With Mild Staining*

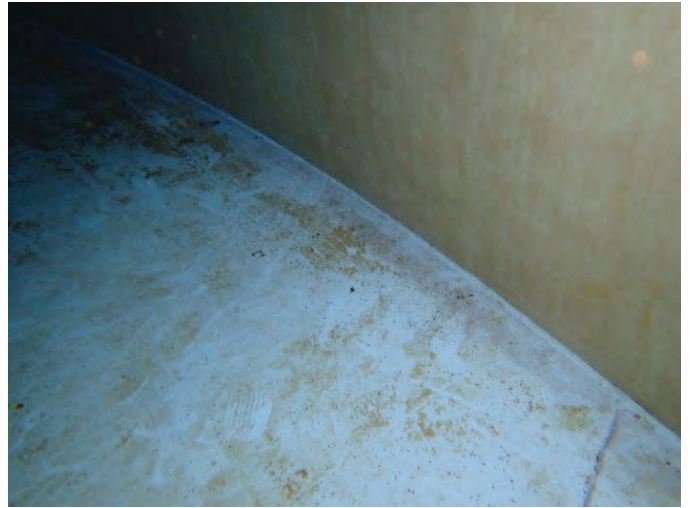
86 *Interior Wall With Mild Staining*

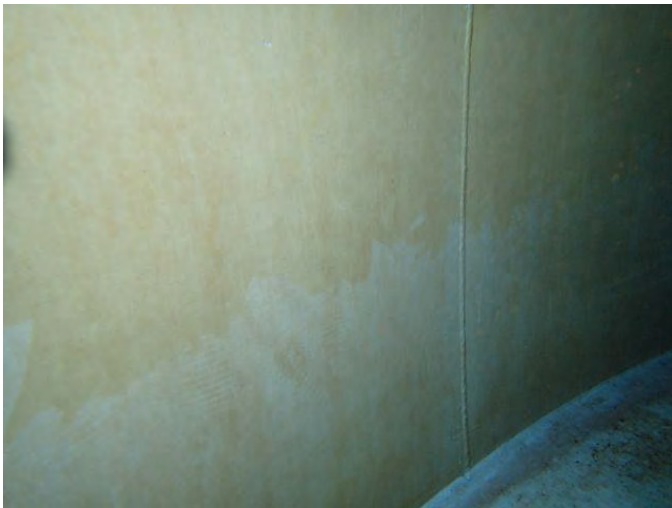
87 *Interior Wall With Mild Staining*

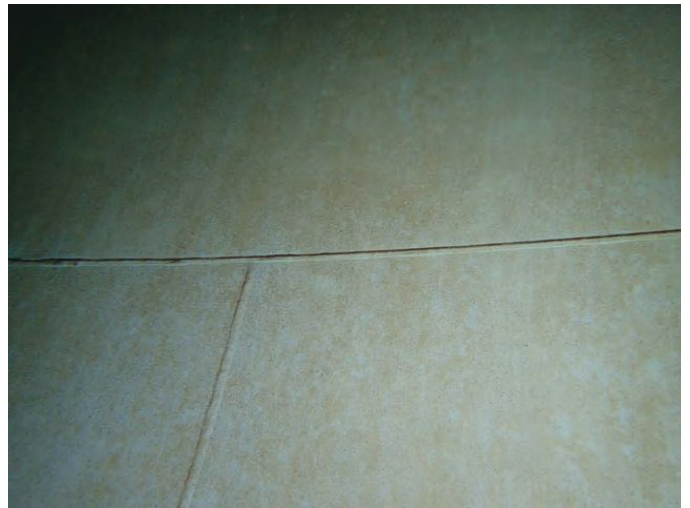
88 *Interior Wall With Mild Staining*

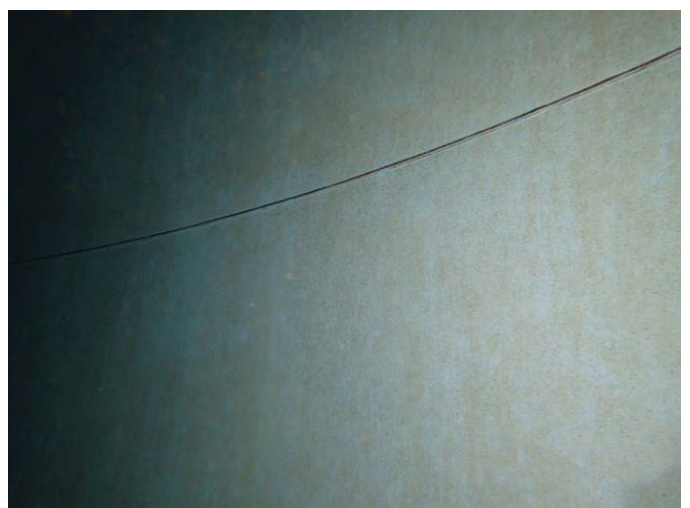
90 *Interior Wall With Mild Staining*

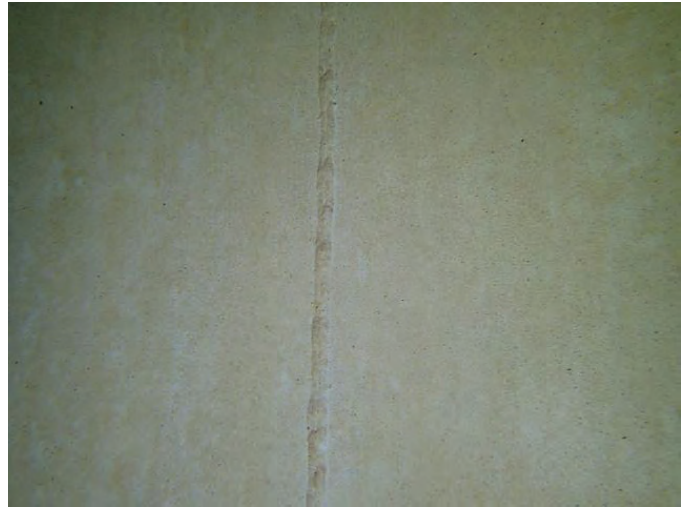
92 *Interior Wall With Mild Staining*

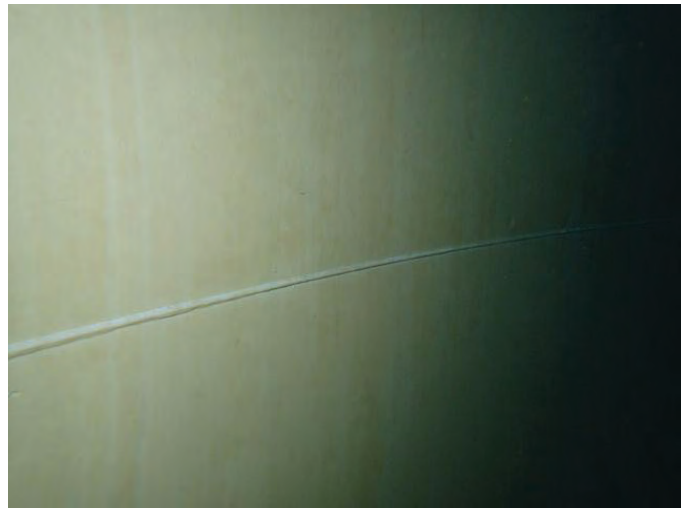
94 *Interior Wall With Mild Staining*

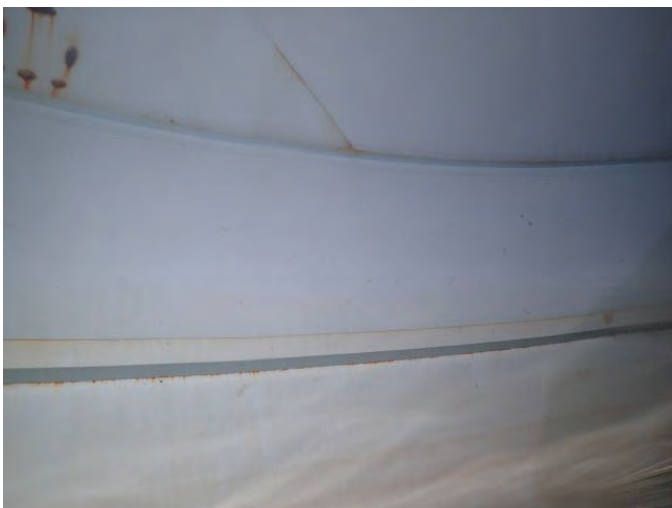
95 *Interior Wall With Mild Staining*
